Manhole Inspection Summary

Manhole # S17A1_021MH

Insp Date: **6/13/08 12:11 PM**

Location Address: **parksley av**

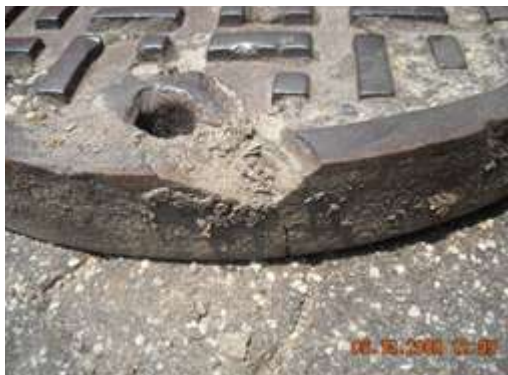
Cover View

Condition: **Worn**

worn cover

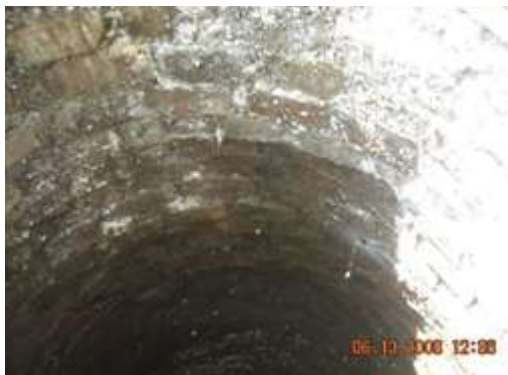
Defect 4

Infiltration: ☐ None ☒ **Joint** ☐ Cracks ☐ Mortar ☐ Roots ☒ **Wall**

infiltration @ corbel wall

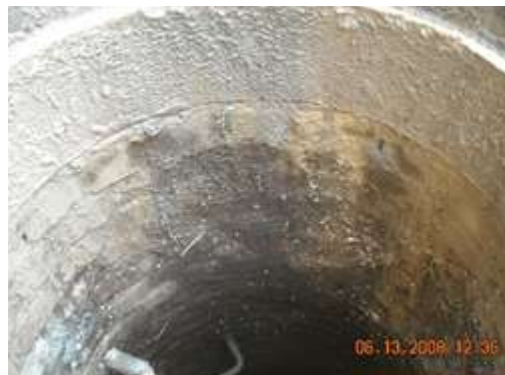
Defect 3

infiltration @ corbel/frame joint

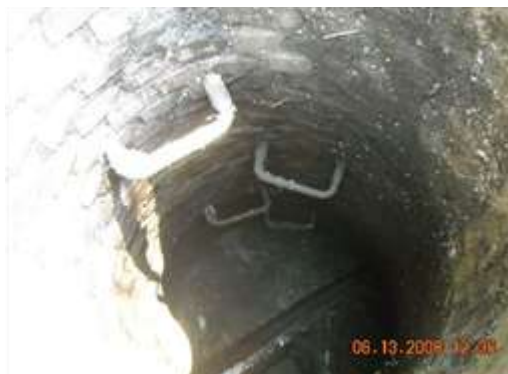
Defect 2

Count: **4** Missing: **0** ☒ **Corroded**

corroded steps

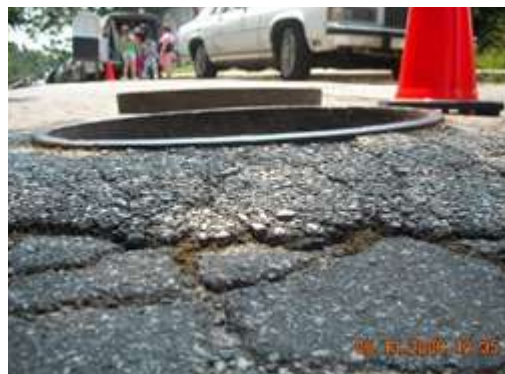
Defect 1

frame above grade

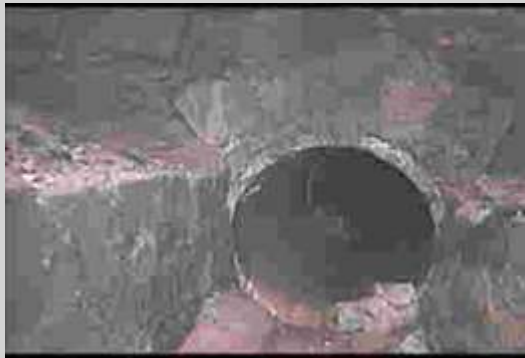
12 O'Clock Outflow

Pipe Height: **8.4** (in.) Rod and Bar (Angled)
Pipe Material: **Clay** ☐ Pipe Lined
Invert Depth: **10.19** (ft.) Flow Characteristics: **Slow**
Deposits: ☐ None ☐ Mud ☒ **Sludge** ☐ Debris ☐ Grease
Silt Depth: **1** (in.) Deposits Extent: **Light**
Infiltration: **None** Pipe Seal Cond: **Sound**

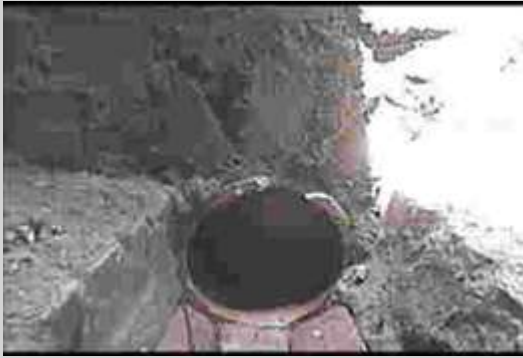
6 O'Clock Inflow

Infiltration: **None** Pipe Seal Cond: **Broken**
